AN INVESTIGATION OF WEB STRESSES IN REINFORCED CONCRETE BEAMS

PART II RESTRAINED BEAMS

FRANK E. RICHART

BULLETIN NO. 175
ENGINEERING EXPERIMENT STATION

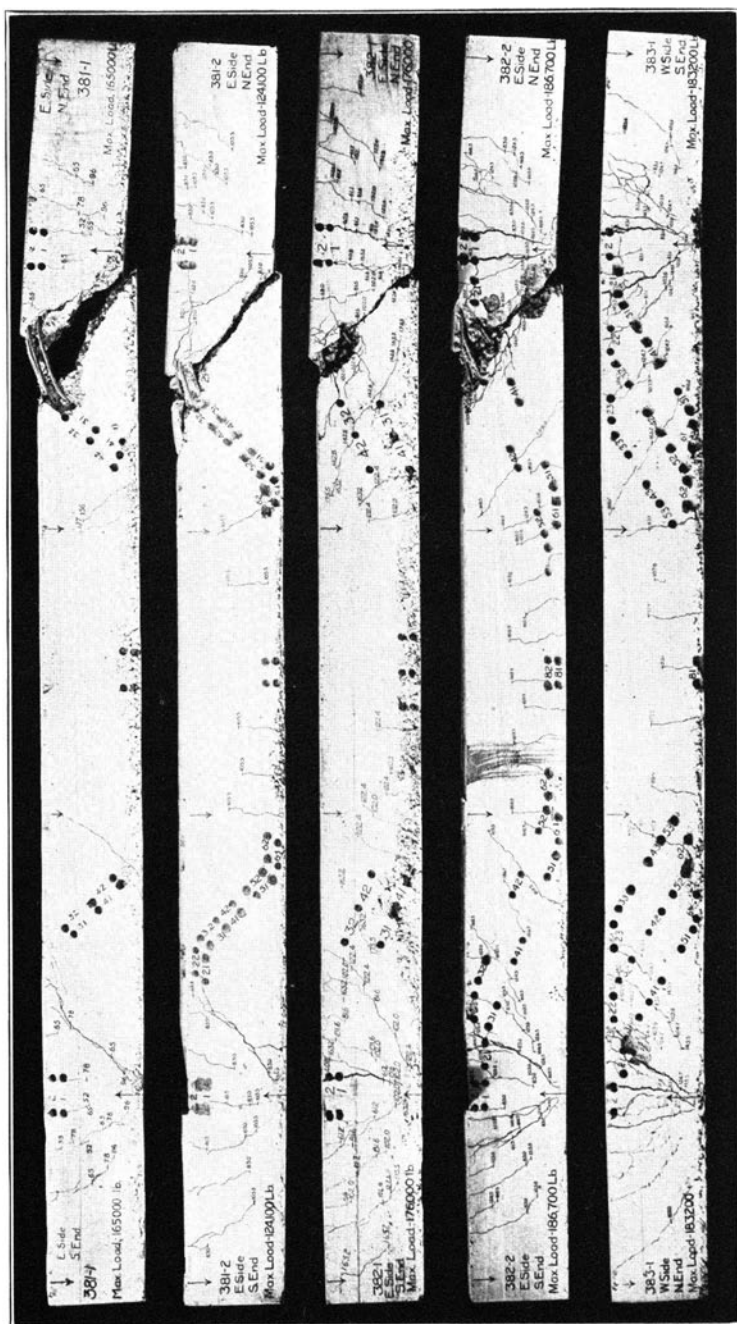
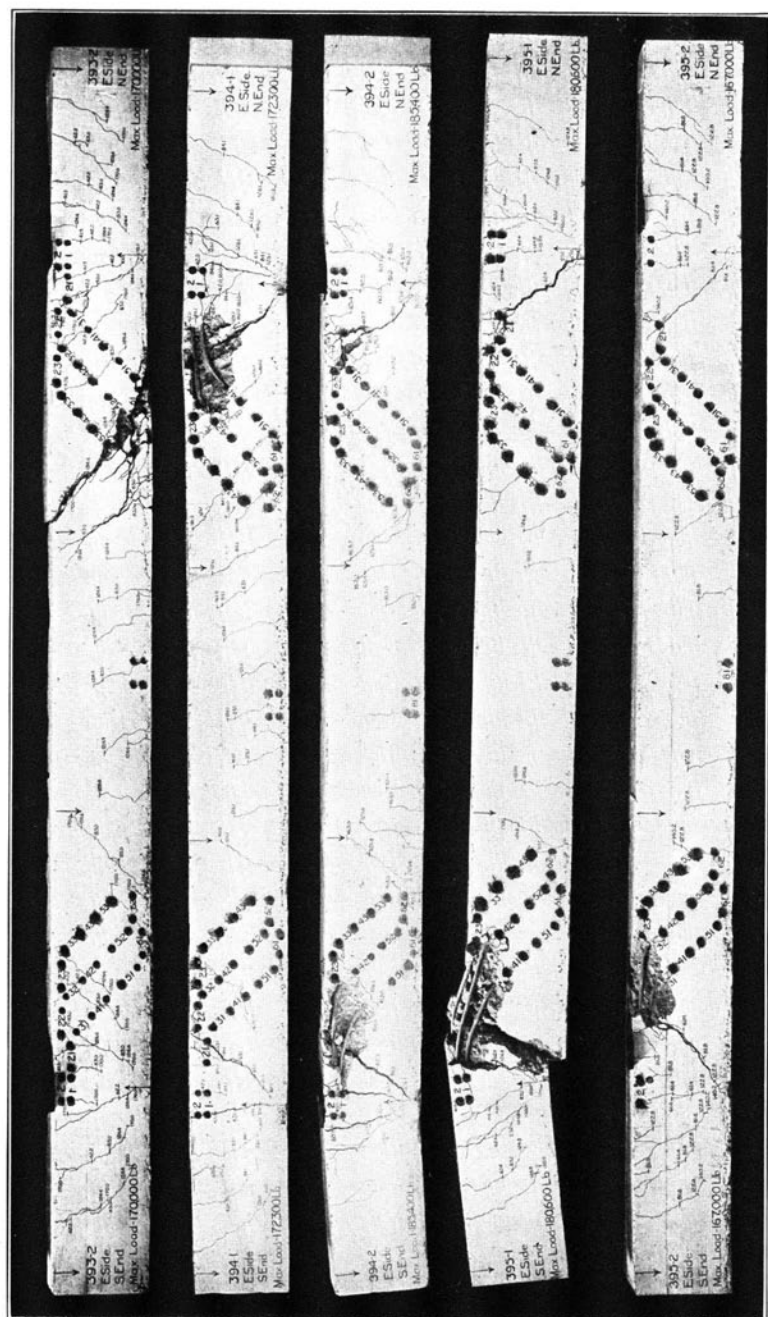
FIG. 12. VIEWS OF BEAMS AFTER TESTING, SERIES OF 1917

FIG. 13. VIEWS OF BEAMS AFTER TESTING, SERIES OF 1917

FIG. 14. VIEWS OF BEAMS AFTER TESTING, SERIES OF 1917

FIG. 15. VIEWS OF BEAMS AFTER TESTING, SERIES OF 1917

FIG. 16. VIEWS OF BEAMS AFTER TESTING, SERIES OF 1917

FIG. 17. VIEWS OF BEAMS AFTER TESTING, SERIES OF 1917

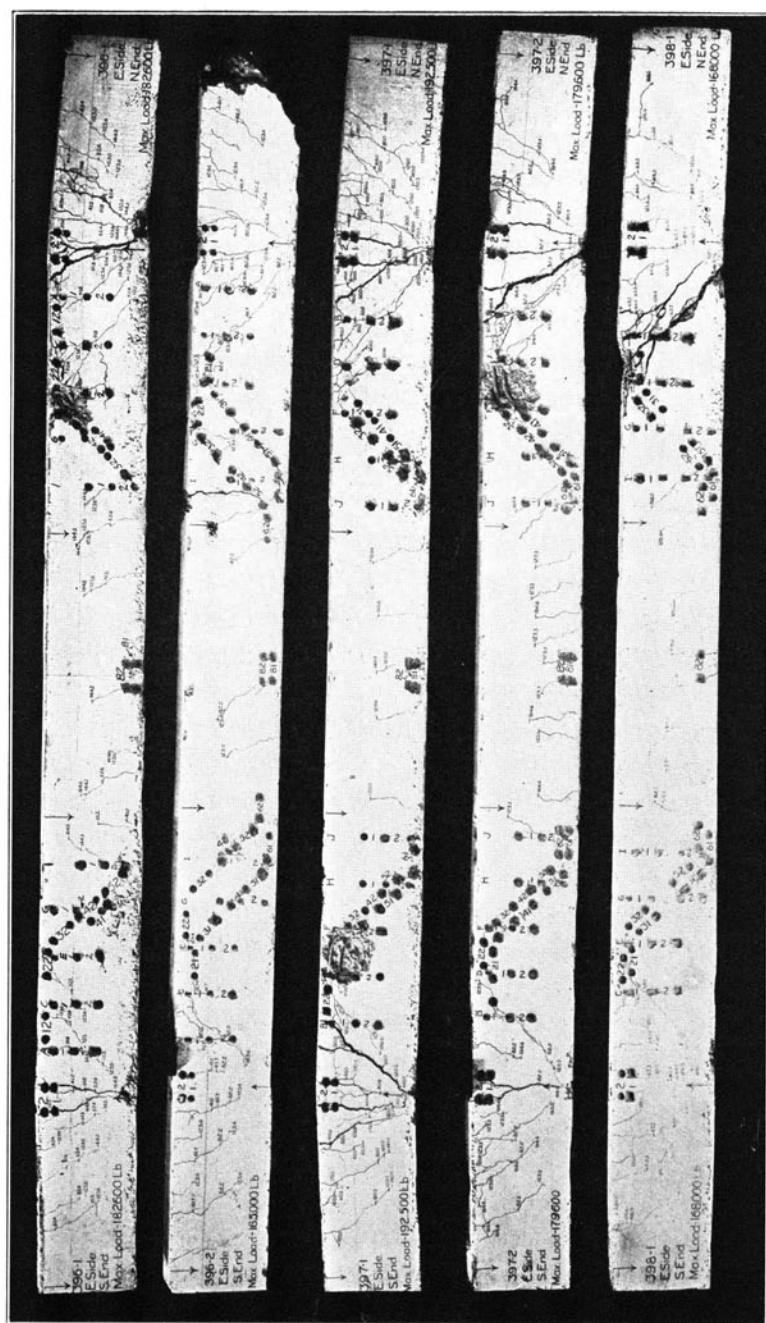
FIG. 18. VIEWS OF BEAMS AFTER TESTING, SERIES OF 1917

FIG. 19. VIEWS OF BEAMS AFTER TESTING, SERIES OF 1917
